Monitoring Data Record

Project Title: I-2511CB (I-85 Widening) COE Action ID: 200221534
Stream Name: Town Creek (Site 5) DWQ Number: 040271
City, County and other Location Information: Rowan County, I-85 Widening (-TI-PINC Sta. 20+35)
Date Construction Completed: Water turned on 12/6/06, Stream reforestation completed 12/13/06
Monitoring Year: (1) of 5
Ecoregion: _____ 8 digit HUC unit 03040103
USGS Quad Name and Coordinates: _____

Town Creek

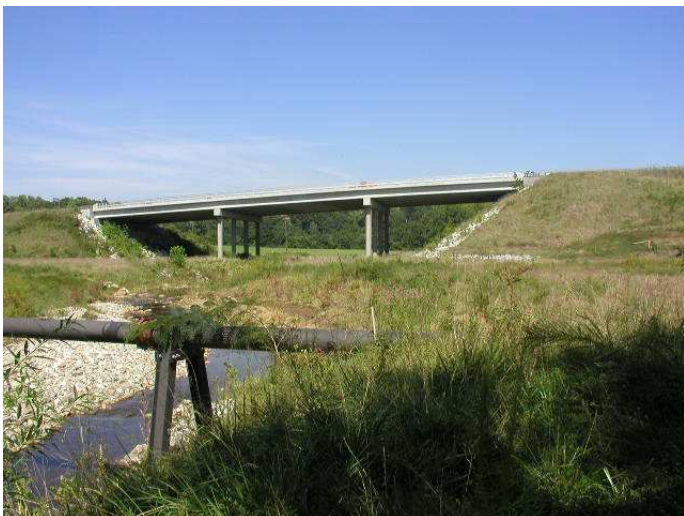
(Overview looking downstream of buffer area)

During the last monitoring evaluation it was noted that the buffer area was lacking planted vegetation.

Estimated causes, and proposed/required remedial action: The buffer area was replanted with river birch, swamp chestnut oak, and willow oak on 2/29/08.
